PRELIMINARY ASSESSMENT REPORT

**WOOD PROTECTION COMPANY
HOUSTON, TEXAS**

EPA CERCLA ID NO.: TXD059345116

September 1997

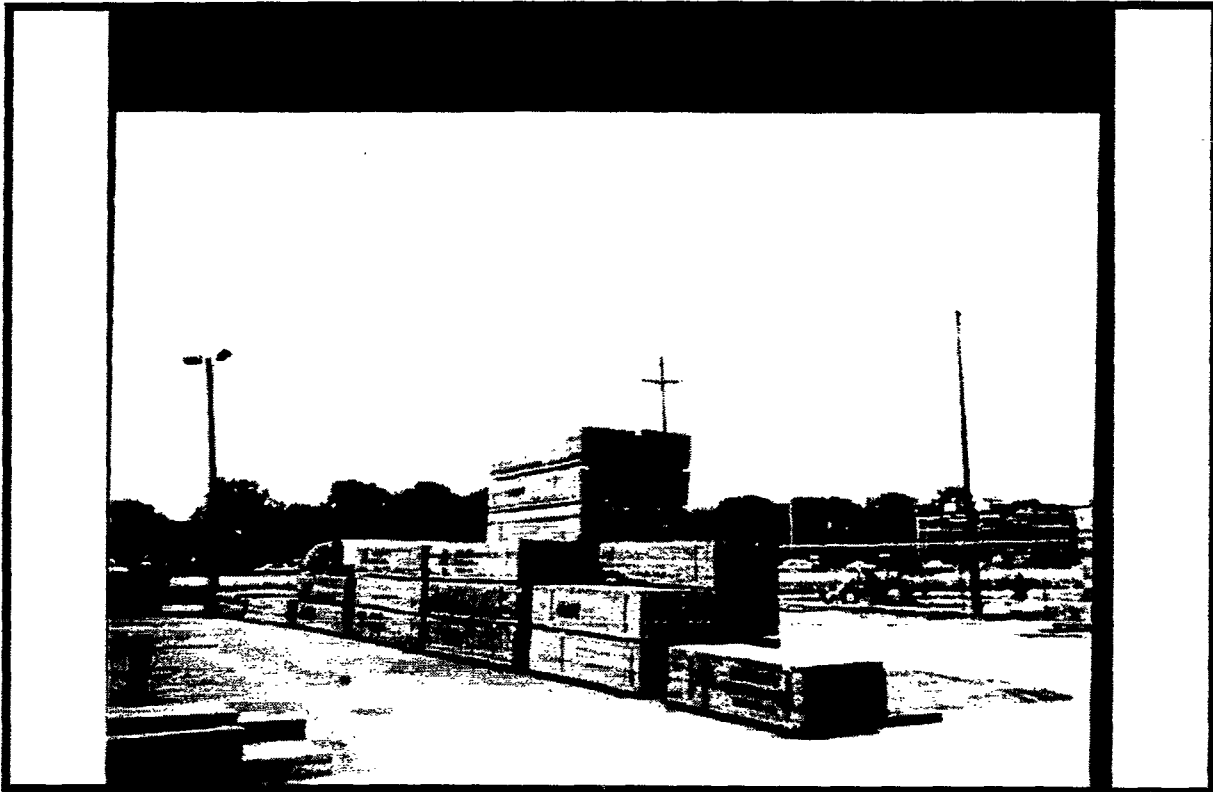
Photograph: 2

Site Name:	Wood Protection Co.
Site Location:	Houston, TX
Weston Work Order:	11098-122-033-0001
Photographer:	Dennis Hayes
Witness:	Carol La Breche
Date of Photograph:	05/21/97
Description:	(Facing East) Treated wood storage area.

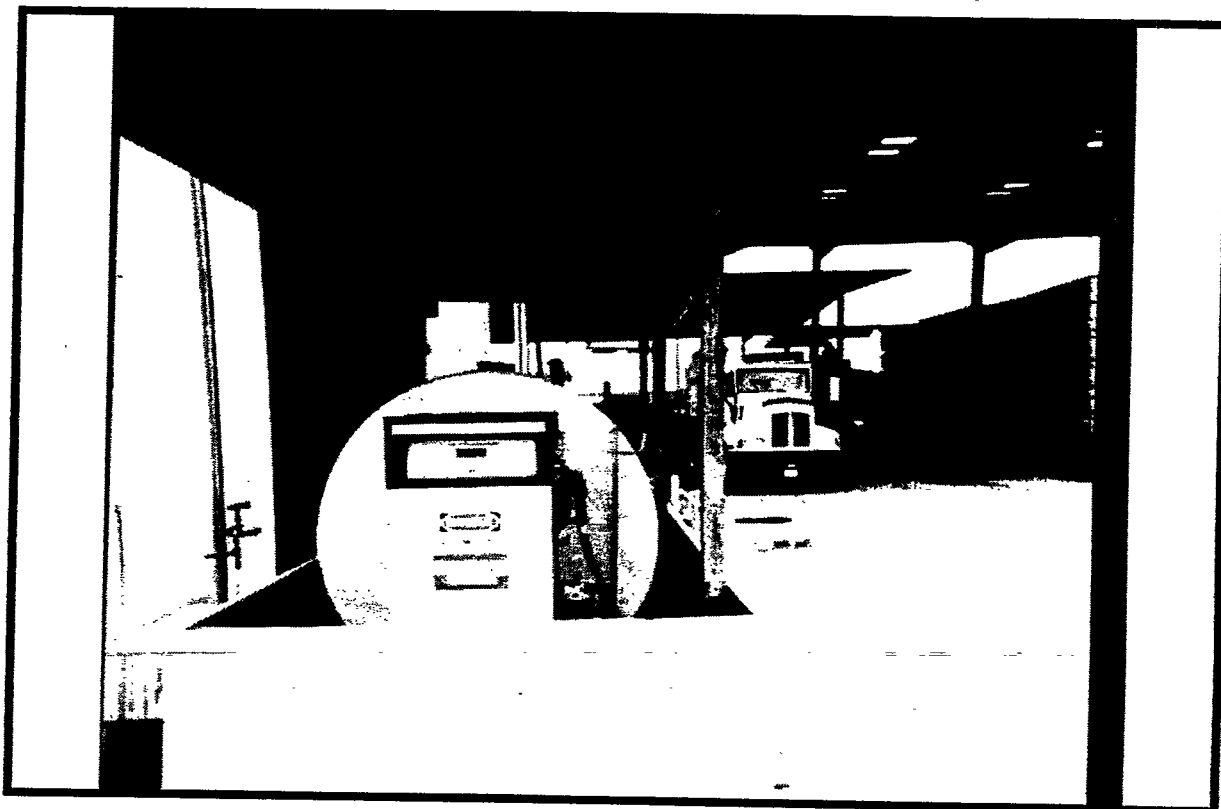
Photograph: 3

Site Name:	Wood Protection Co.
Site Location:	Houston, TX
Weston Work Order:	11098-122-033-0001
Photographer:	Dennis Hayes
Witness:	Carol La Breche
Date of Photograph:	05/21/97
Description:	3,000-gallon diesel tank in secondary containment.

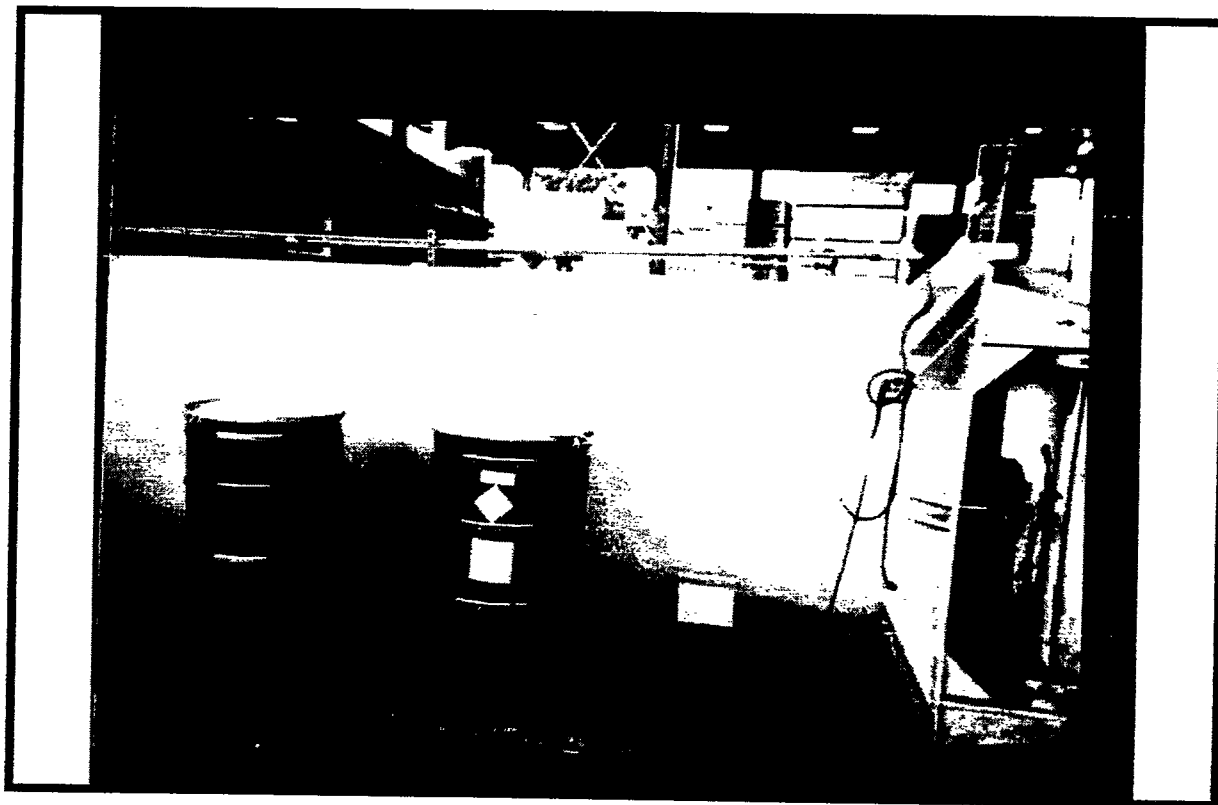
Photograph: 8

Site Name:	Wood Protection Co.
Site Location:	Houston, TX
Weston Work Order:	11098-122-033-0001
Photographer:	Dennis Hayes
Witness:	Carol La Breche
Date of Photograph:	05/21/97
Description:	Hazardous waste storage of treated lumber debris.

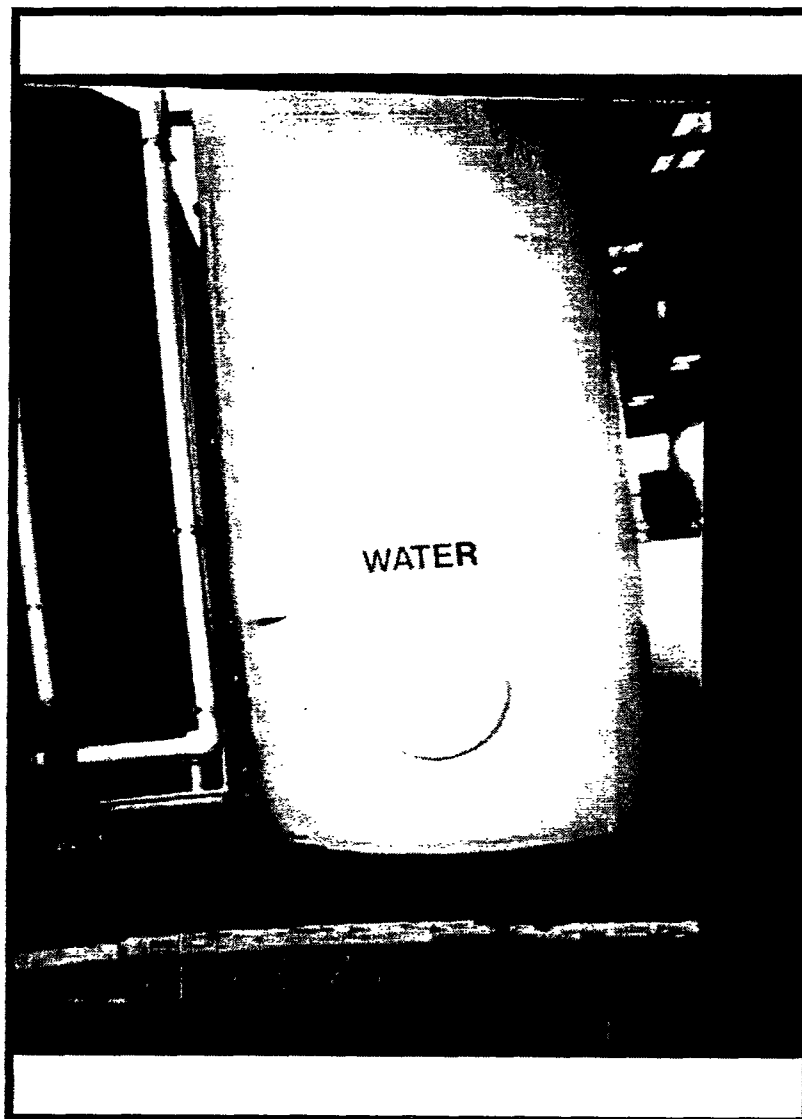
Photograph: 9

Site Name:	Wood Protection Co.
Site Location:	Houston, TX
Weston Work Order:	11098-122-033-0001
Photographer:	Dennis Hayes
Witness:	Carol La Breche
Date of Photograph:	05/21/97
Description:	Water tank.

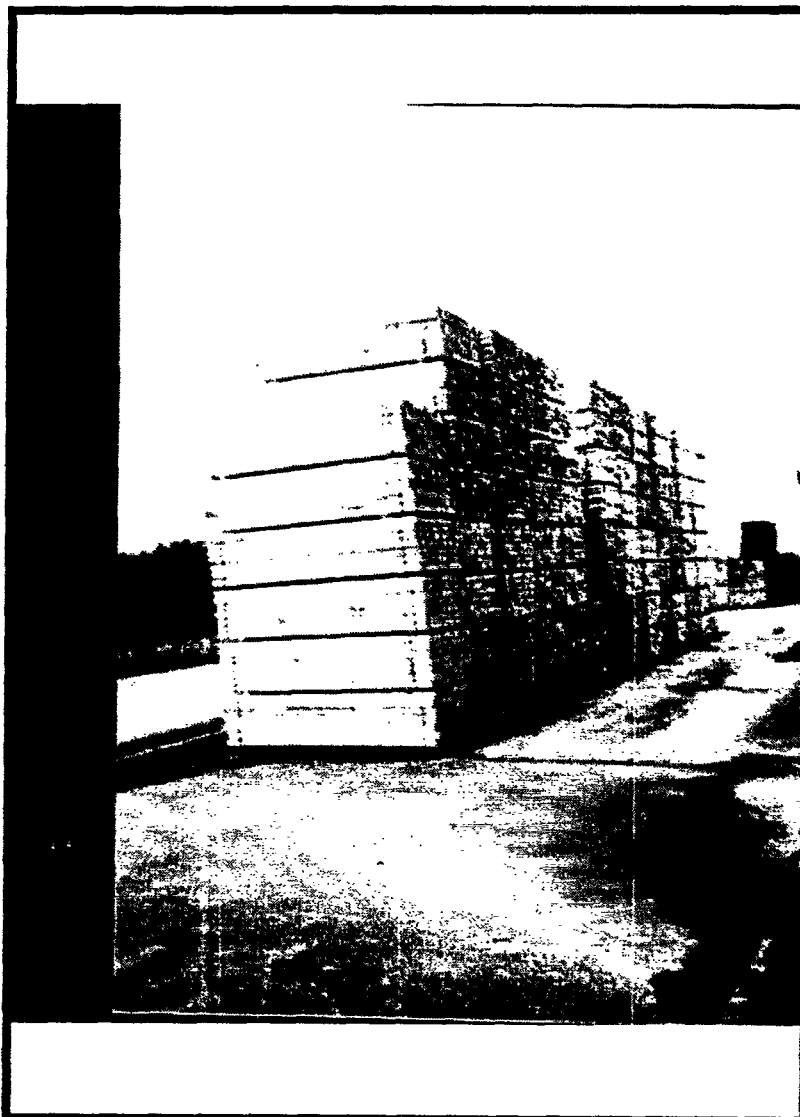
Photograph: 10

Site Name:	Wood Protection Co.
Site Location:	Houston, TX
Weston Work Order:	11098-122-033-0001
Photographer:	Dennis Hayes
Witness:	Carol La Breche
Date of Photograph:	05/21/97
Description:	Untreated lumber storage area.

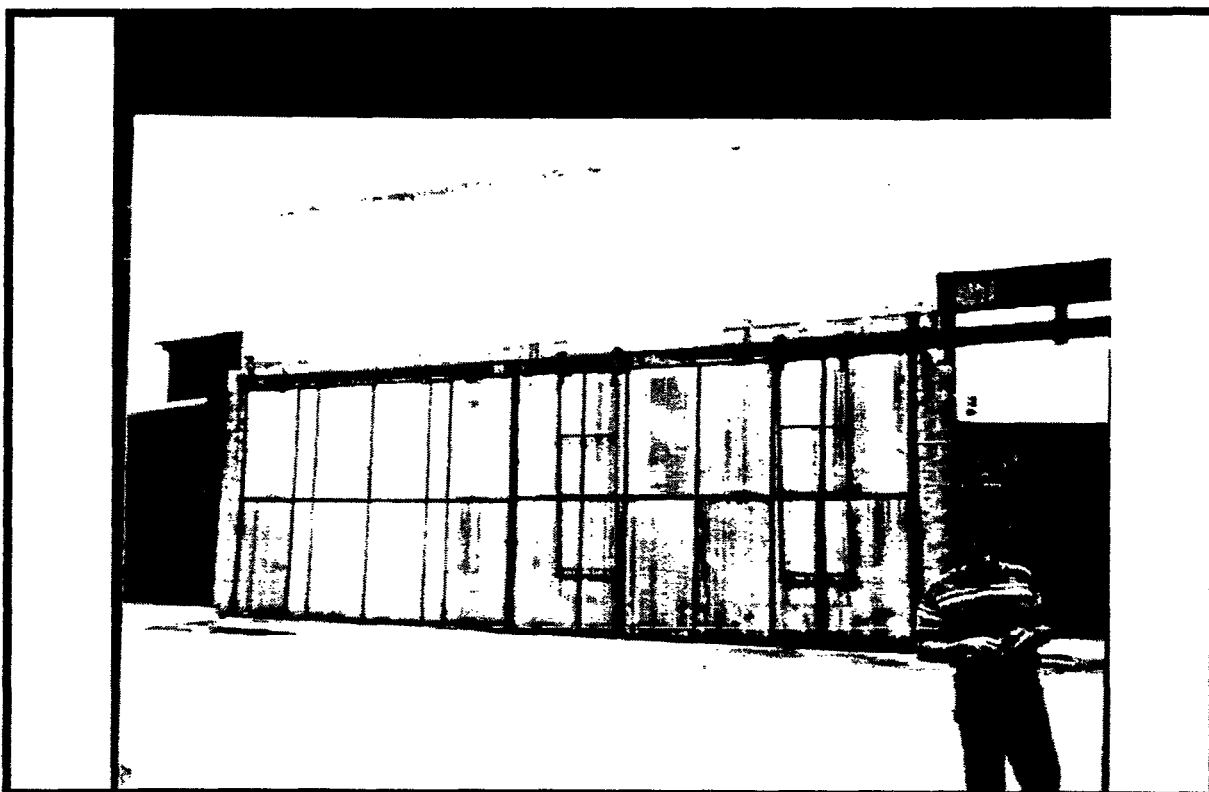
Photograph: 11

Site Name:	Wood Protection Co.
Site Location:	Houston, TX
Weston Work Order:	11098-122-033-0001
Photographer:	Dennis Hayes
Witness:	Carol La Breche
Date of Photograph:	05/21/97
Description:	Drying kiln.

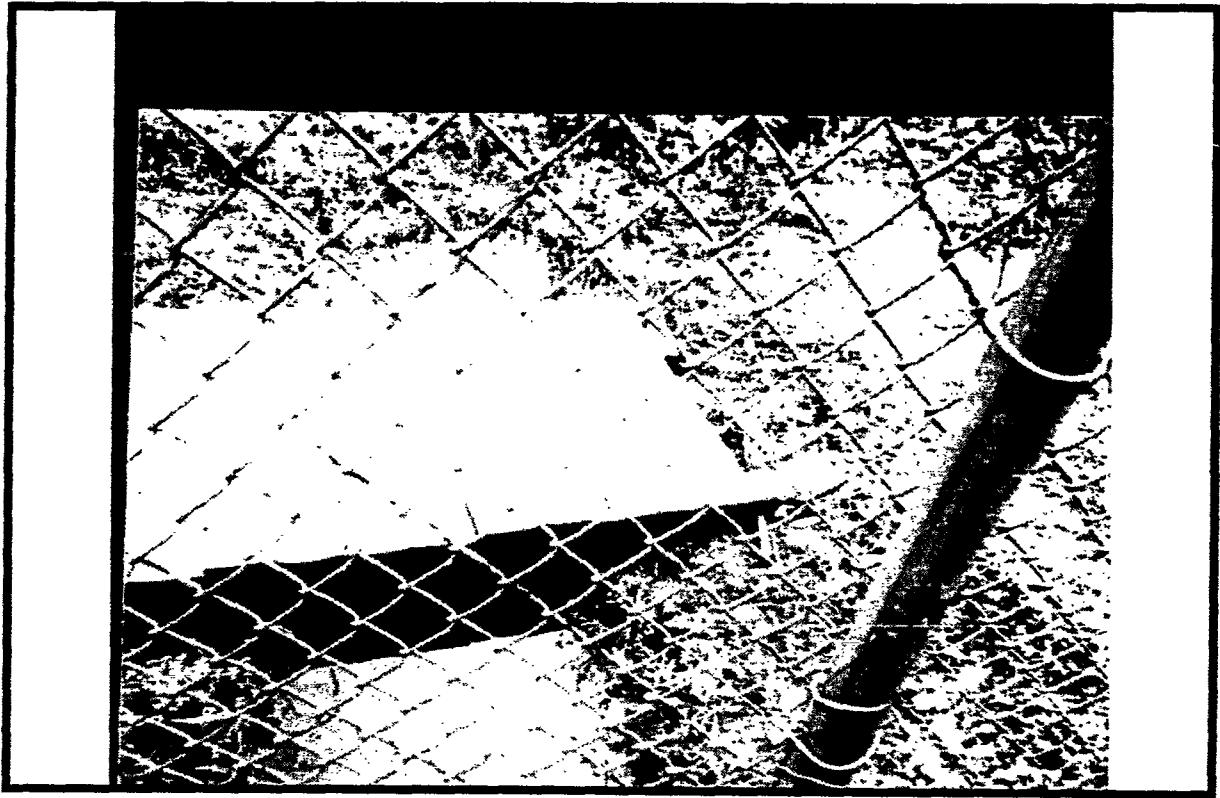
Photograph: 12

Site Name:	Wood Protection Co.
Site Location:	Houston, TX
Weston Work Order:	11098-122-033-0001
Photographer:	Dennis Hayes
Witness:	Carol La Breche
Date of Photograph:	05/21/97
Description:	East Stormwater Culvert.

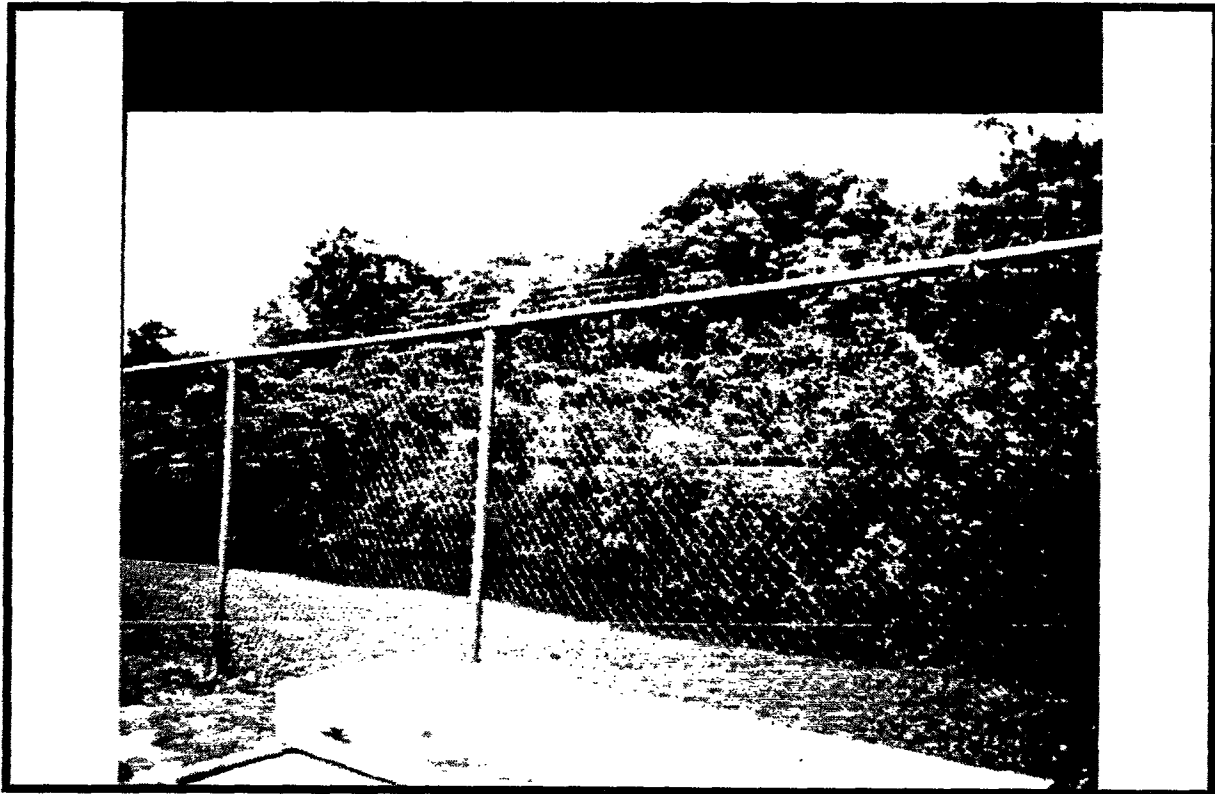
Photograph: 13

Site Name:	Wood Protection Co.
Site Location:	Houston, TX
Weston Work Order:	11098-122-033-0001
Photographer:	Dennis Hayes
Witness:	Carol La Breche
Date of Photograph:	05/21/97
Description:	Drainage ditch on the north side of the site.
